SIEGE MUSEUM ASSESSMENT

15 WEST BANK STREET
PETERSBURG, VIRGINIA

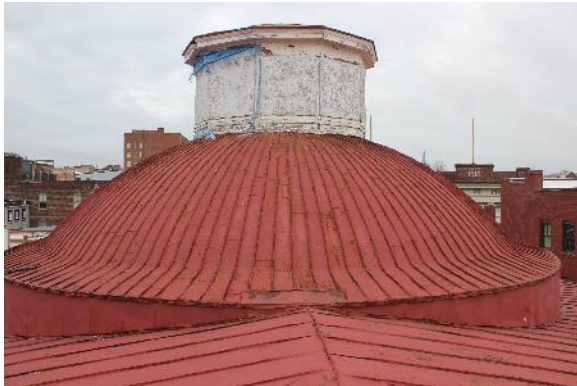
Figure 1.1: Roof, Siege Museum. Dome roof and cupola. (Photograph 7 April 2015)

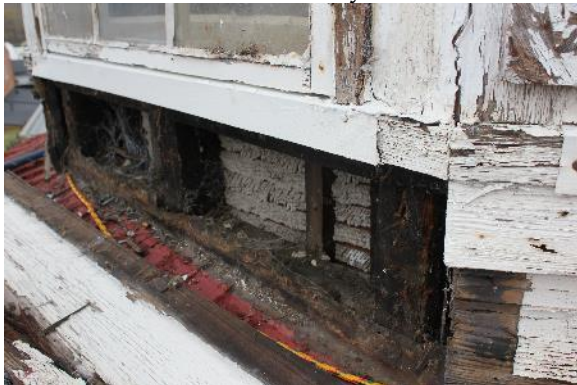
Figure 1.2: Roof, Siege Museum. Cupola wall cavity detail. (Photograph 7 April 2015)

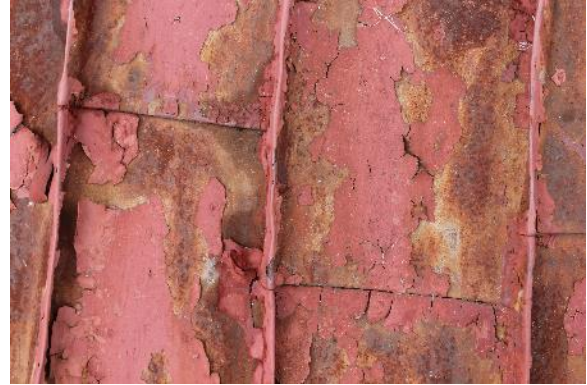
Figure 1.3: Roof, Siege Museum. Detail of roof surface. Note the flaking roof coating and rust beneath. (Photograph 7 April 2015)

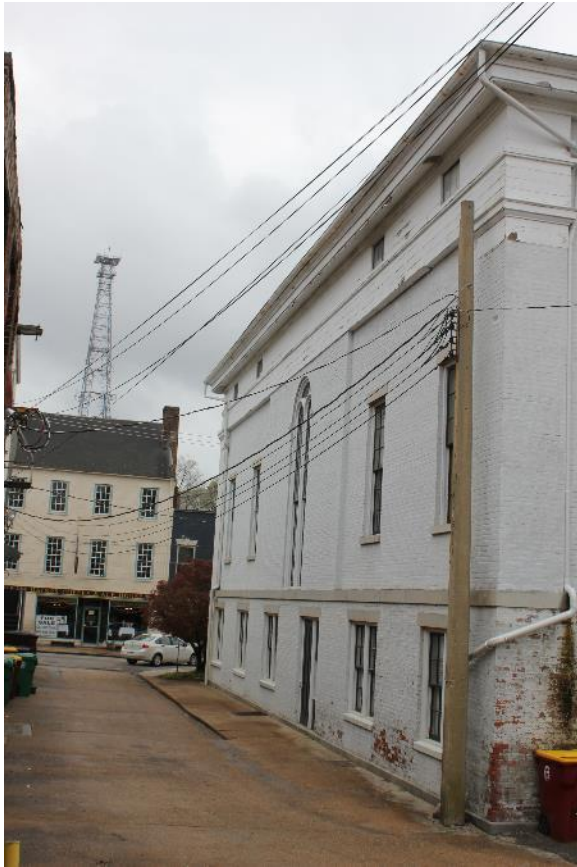
Figure 1.7: East Elevation, Siege Museum. Cornice Detail. (Photograph 7 April 2015)

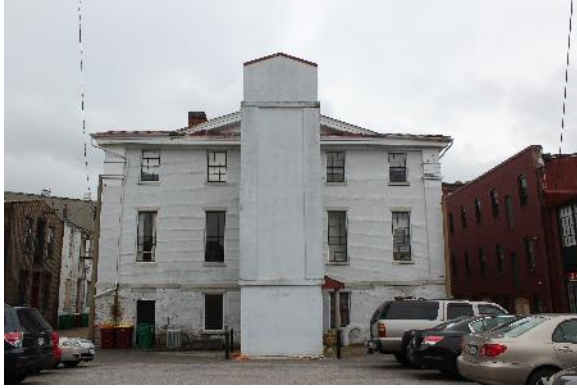
Figure 1.14: North Elevation, Siege Museum. (Photograph 7 April 2015)

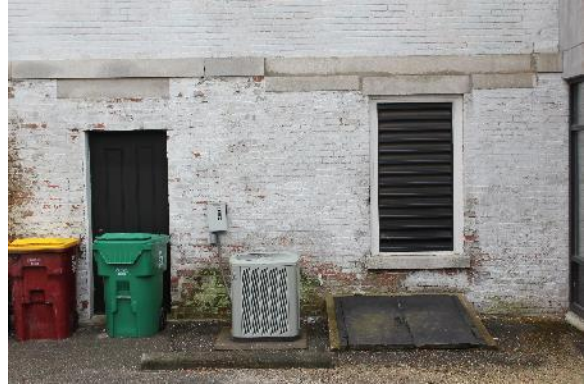
Figure 1.15: North Elevation, Siege Museum. Note the biological growth on the wall and the slope of the asphalt lot sloping toward the building. (Photograph 7 April 2015)

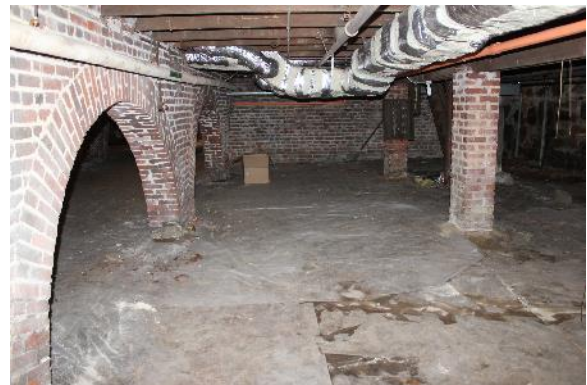
Figure 1.36: Basement, Siege Museum (Photograph 7 April 2015)

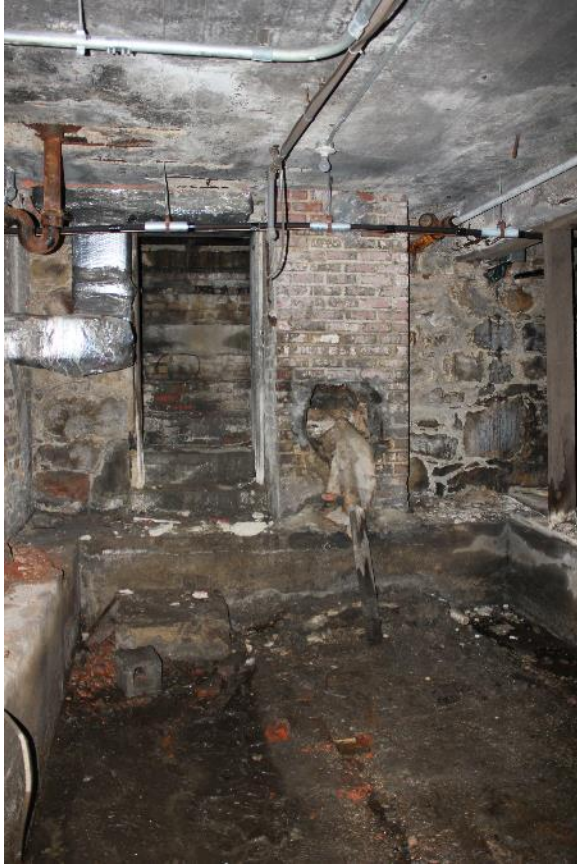
Figure 1.37: Basement, Siege Museum. (Photograph 7 April 2015)

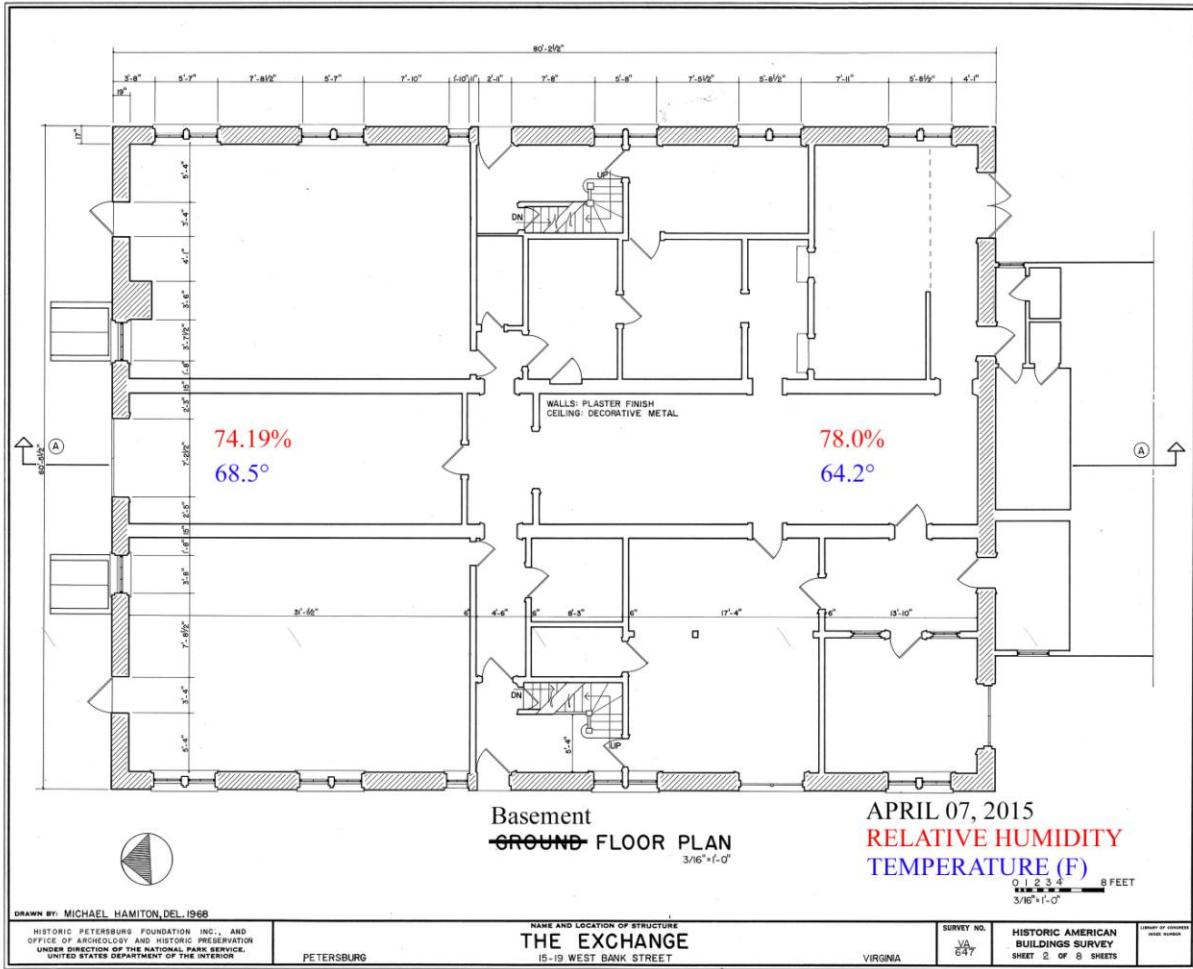
Appendix A: Relative Humidity and Temperature Readings

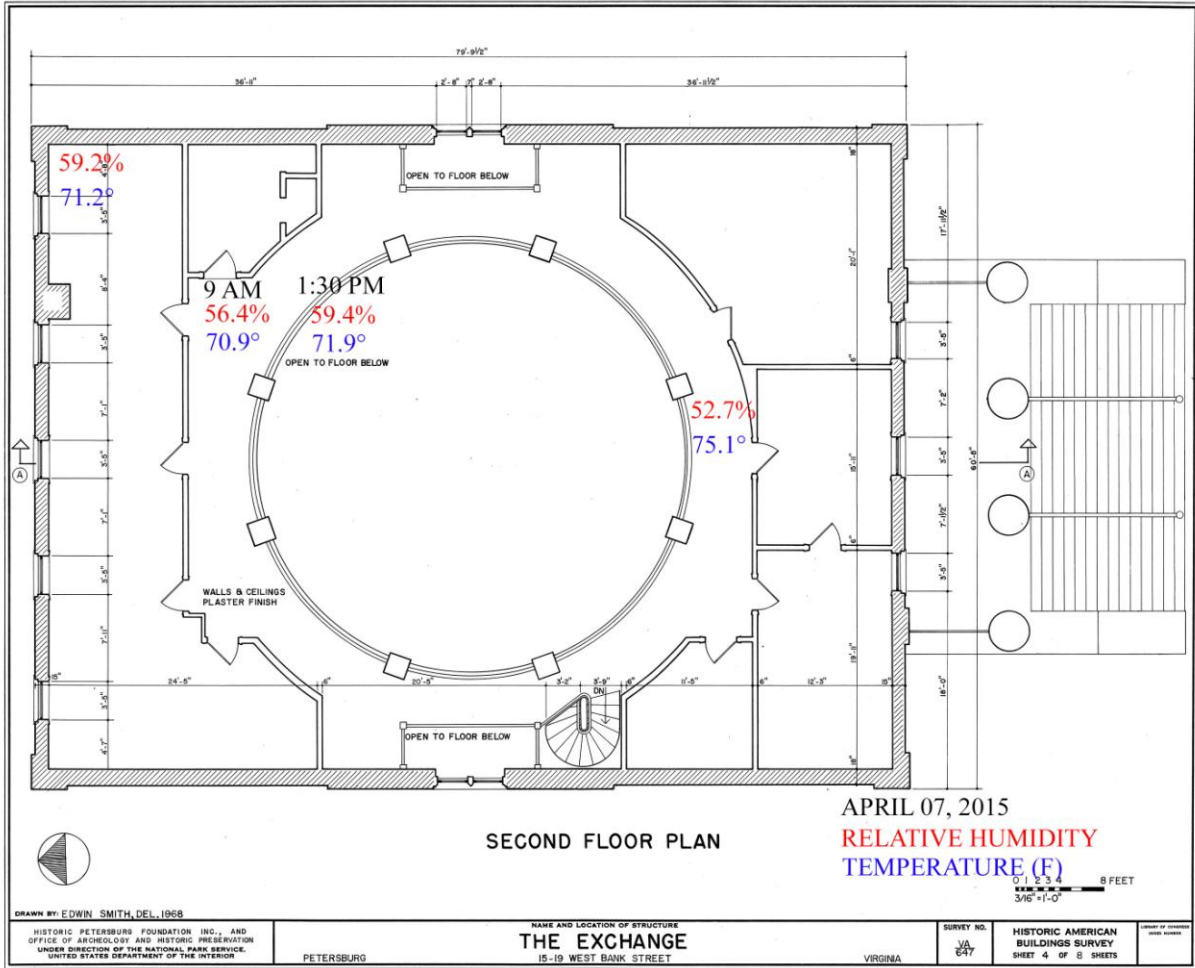
Part 2: Maintenance and Architectural Rehabilitation Guidelines

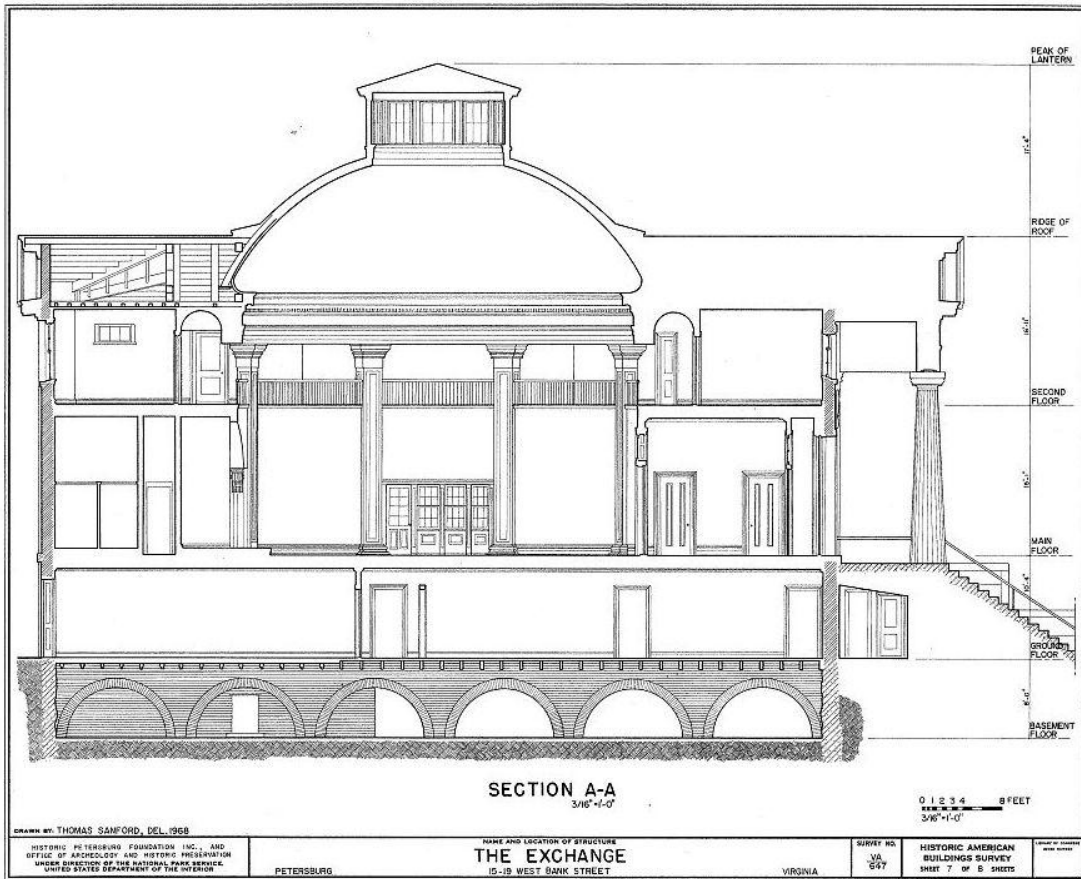
End of Structural Evaluation

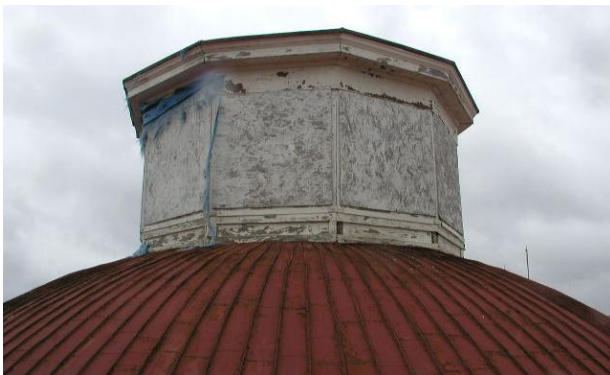
- The front portico with a gable shaped roof area with standing seam metal roof panels sloping to exterior half round gutters. Also noted metal clad water table area at base of front gable. Similar gable area also found at rear of the main roof area.
- The main body of the roof area consists of a hip shaped sloped roof again covered with standing seam metal roofing and draining to exterior gutters. This roof area transitions into the dome structure at the center of the building.
- The dome structure extends vertically from the main roof area and is clad with metal wall panels at the vertical sections and tapered sloped metal panels at the curved roof area.
- The cupola or lantern area contains multiple windows and associated wood trim and is covered with sloped, flat seam, painted metal roof panels.

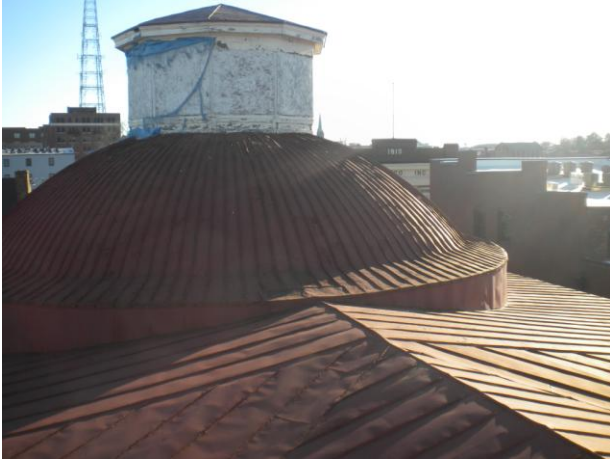
Photo No. 3
General overview of the main roof and dome area.
Photo taken at rear section.

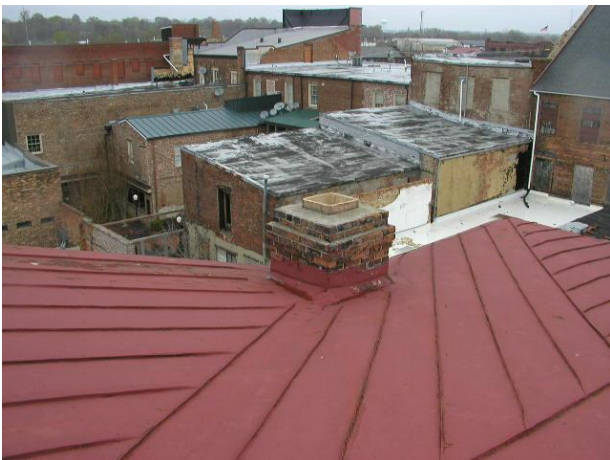
Photo No. 5
General overview on main roof at the rear section.
Chimney noted positioned in the valley area.

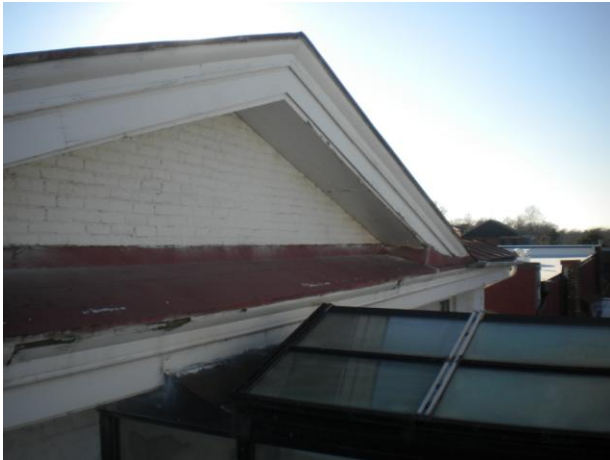
Photo No. 6
Observation –water table area at rear gable. Deteriorated wood trim members noted. Metal cover to be replaced as part of the new roof assembly. Recommend all deteriorated wood trim members to be repaired or replaced and new paint finishes applied.

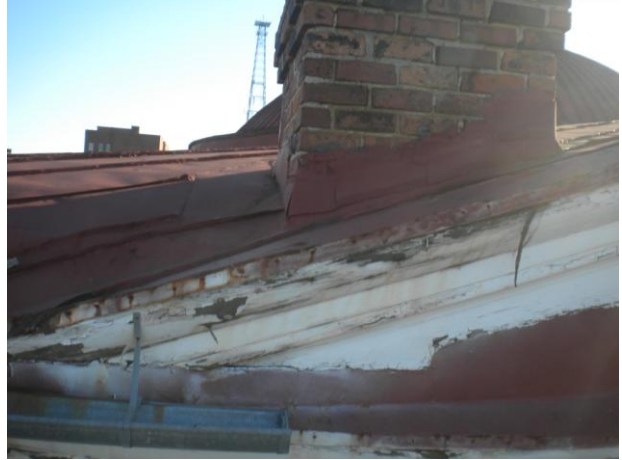
Photo No. 7
Observation of deteriorated conditions at gable trim members. Repairs required. Also modifications to the gutter system noted.

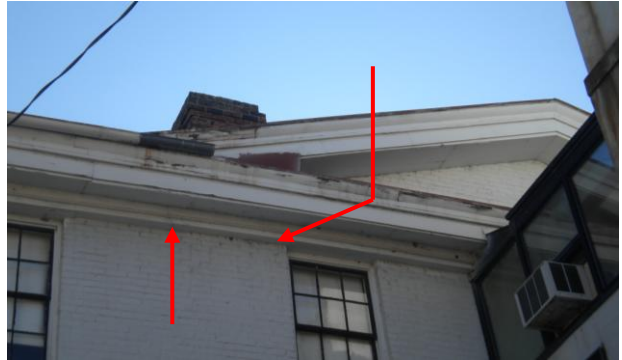
Photo No. 8
General overview of area as discussed in photos no. 6 & 7. As part of the roof renovation, recommend new paint and wood repair down to the brick line as a minimum.

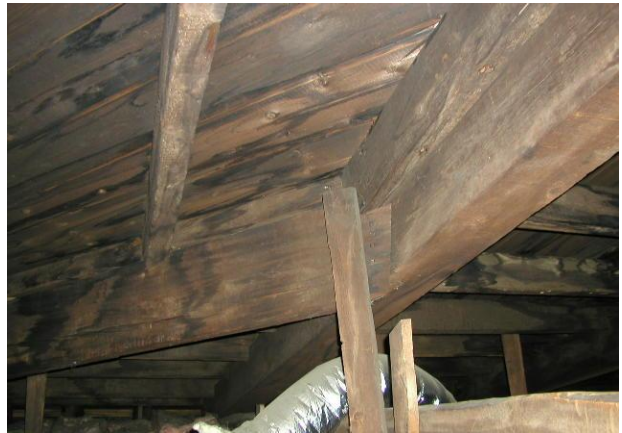
Photo No. 9
General observation of underside of roof deck. Typically dry. Water stains noted on wood components. Reference the structural section of this report for further discussion.

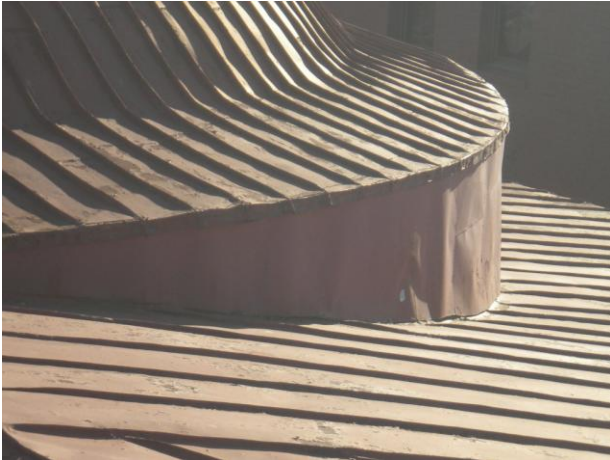
Photo No. 10
General overview of dome structure. Light gauge flat, metal panels observed at vertical section. Standing seam panels observed at dome section with two different slopes noted. Continuous panel lengths conform to the dome shape and are bent to form a drip edge.

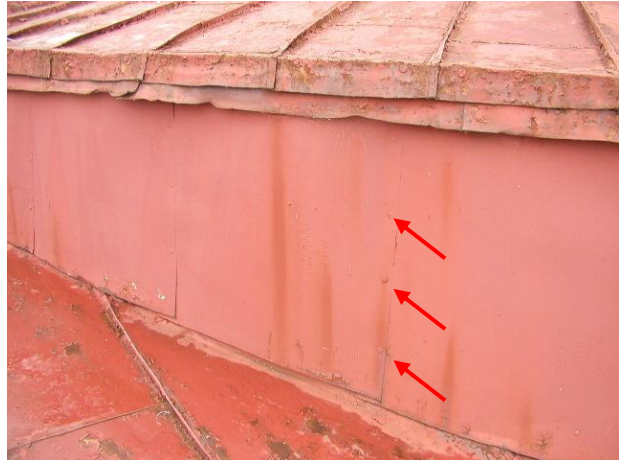
Photo No. 11
Observation of flat wall panels (sheets). Typically nailed into place. Evidence of rust staining also present.

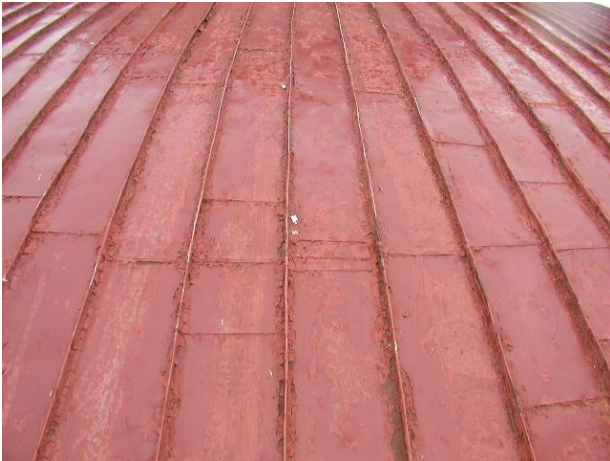
Photo No. 12
Observation - panel runs are fabricated from various lengths of the sheet material and have numerous lap seams. Note the width of the panels. Pans start out at a minimal width at the base and taper to a fairly narrow width at the top of the run.

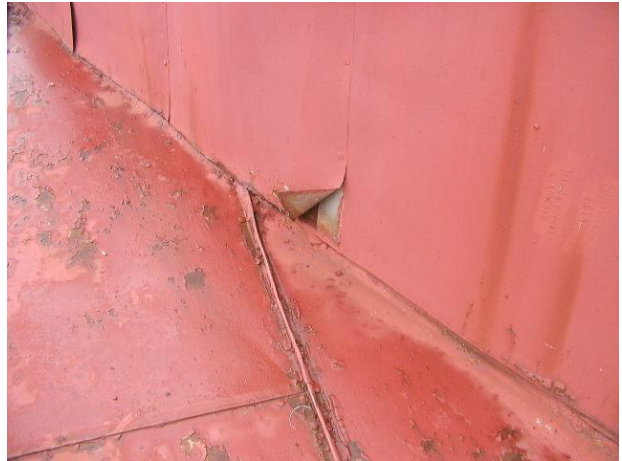
Photo No. 13
Observation - light gauge panel material noted. Painted and unpainted surfaces noted.

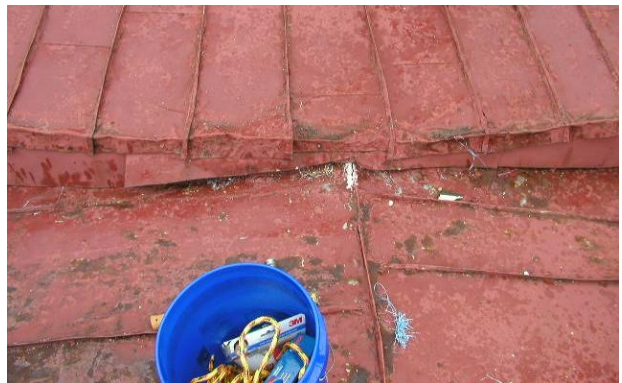
Photo No. 14
Observation of split in metal materials at ridge seam. Solder repair attempt noted.

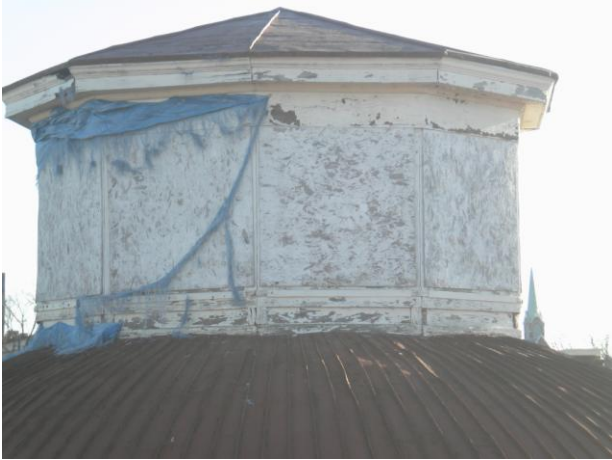
Photo No. 15
Observation of cupola or lantern. Deteriorated wood conditions noted at cornice area and at base. Flat seam panels noted at roof area.

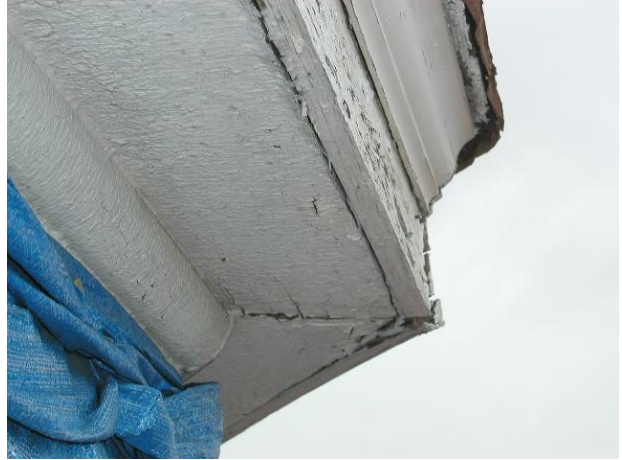
Photo No. 16
General observation of wood and paint finishes.

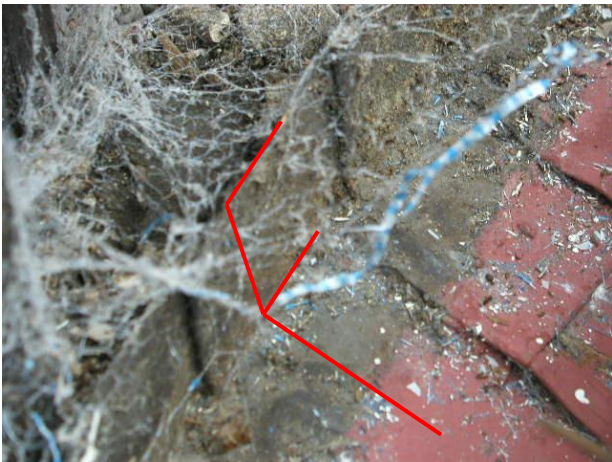
Photo No. 17
Observation – bottom trim board of copula removed to reveal substrate conditions and turned up ends of the standing seam dome roof panels.

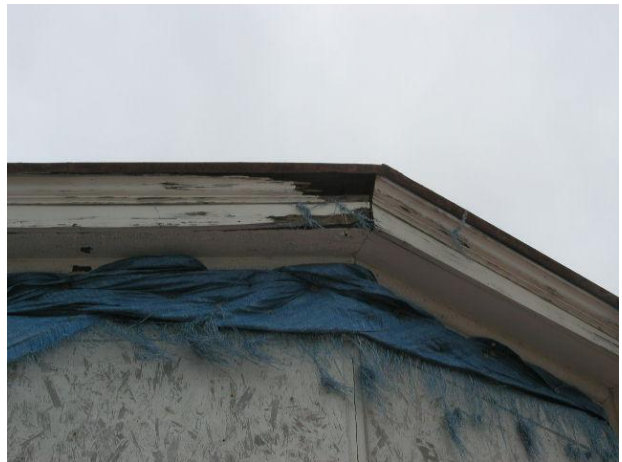
Photo No. 18
Observation – severe wood deterioration at cornice trim.

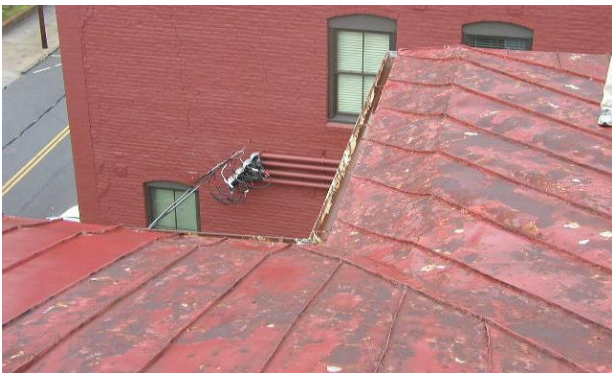
Photo No. 19
Observation at perimeter conditions of main roof area. Transition in roof slope noted. Structural framing below indicates possible built-in gutters at one time. Current gutter conditions shown.

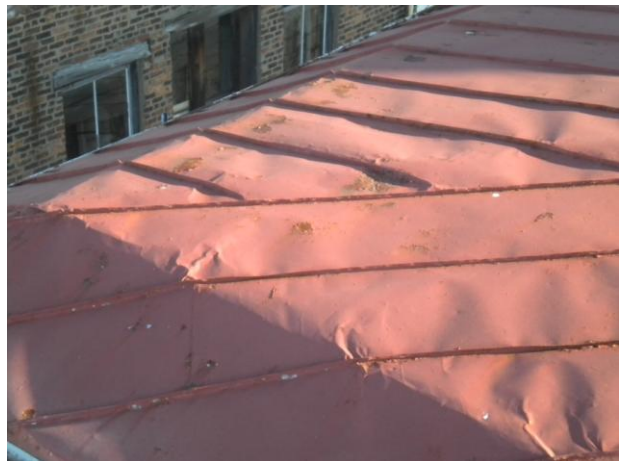
Photo no. 20
Observation – transition in perimeter deck slope.

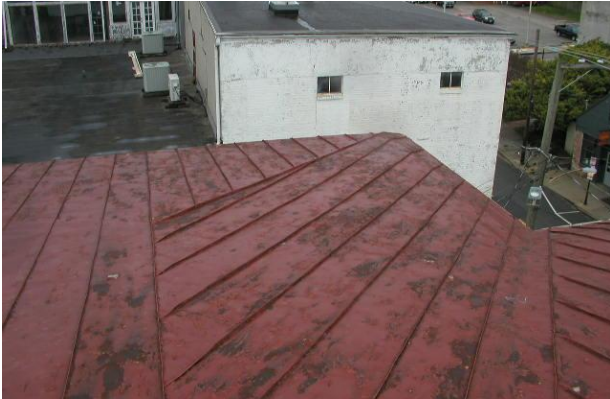
Photo No. 21
Overview of roof slope transitions; slope from ridge to eave, hip detail and valley detail. Panels as installed do not necessarily run parallel to the roof slope. Configurations exist where damming conditions are created and water is forced to run across the standing seams.

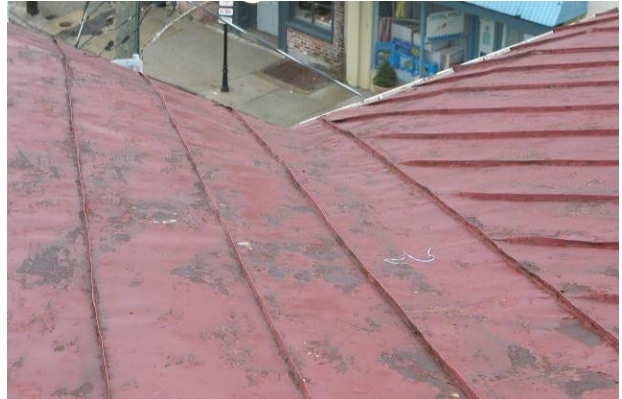
Photo No. 22
Observation – valley area shown. Note position of panels adjacent to the valley.

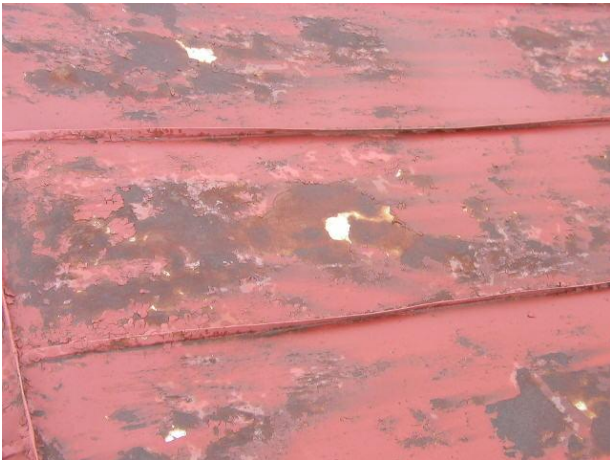
Photo No. 23
Observation – typical conditions for the paint finish.

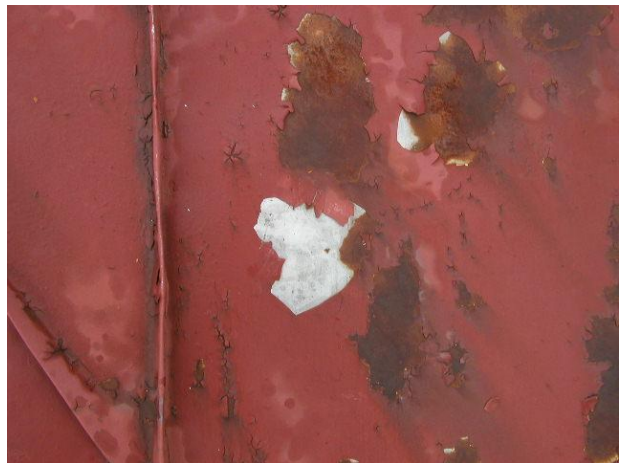
Photo No. 24
Again deteriorated paint finish. The red finish first goes and exposes the tin finish. The tin coating then wears to expose the steel material and rust begins to form.

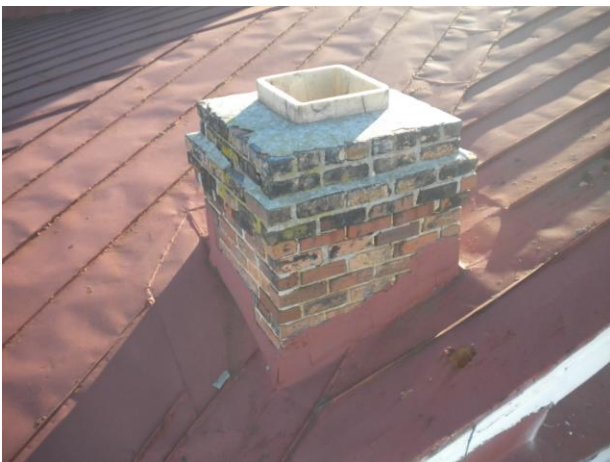
Photo No. 25
General overview of chimney. Located in valley area. Some repairs noted.

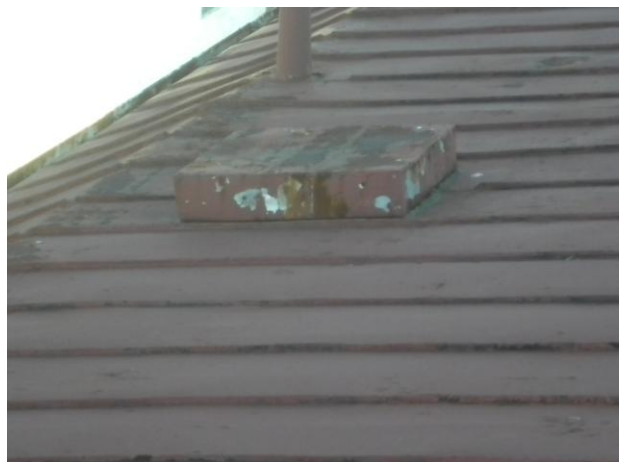
Photo No. 26
Observation – roof access hatch. Deteriorated finishes noted.

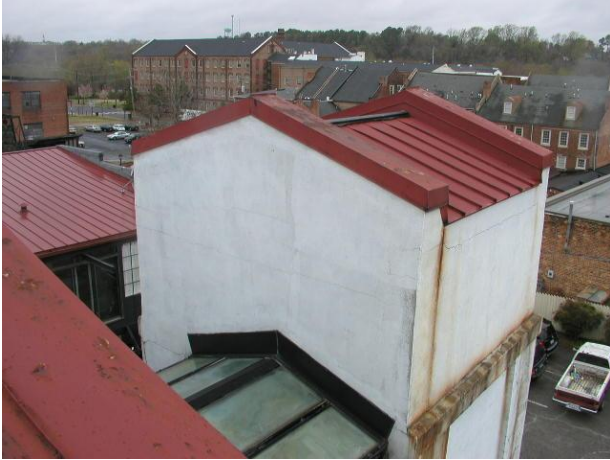
Photo No. 27
General overview of elevator roof area. Similar standing seam panels noted. Also metal coping covers. Deterioration noted on paint finishes. A Retro-fit ridge cover has been added.

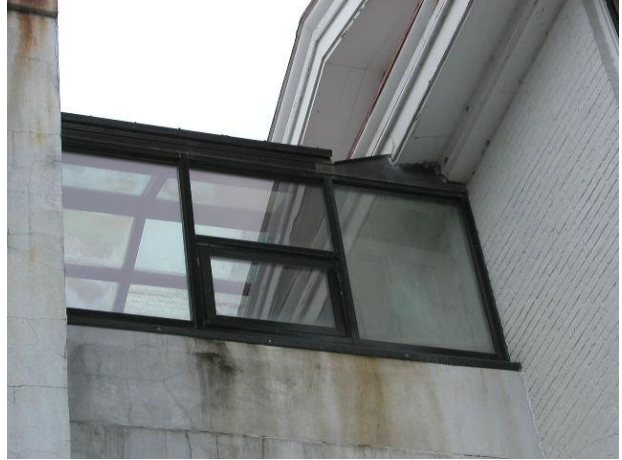
Photo No. 28
Observation – deteriorated conditions noted on stucco finishes. Specific damages noted below window sill area.

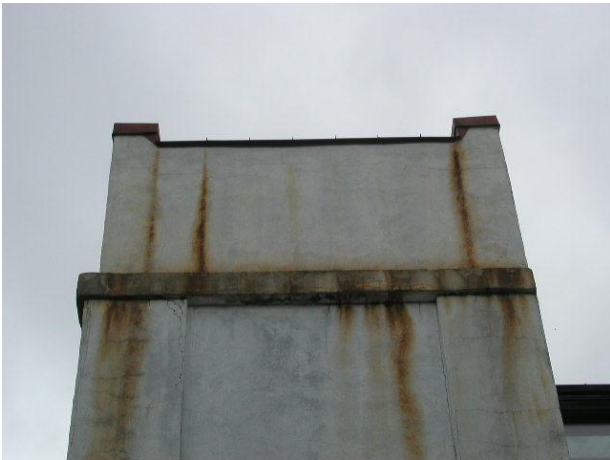
Photo No. 29
Observation – rust stains noted on stucco wall finish.

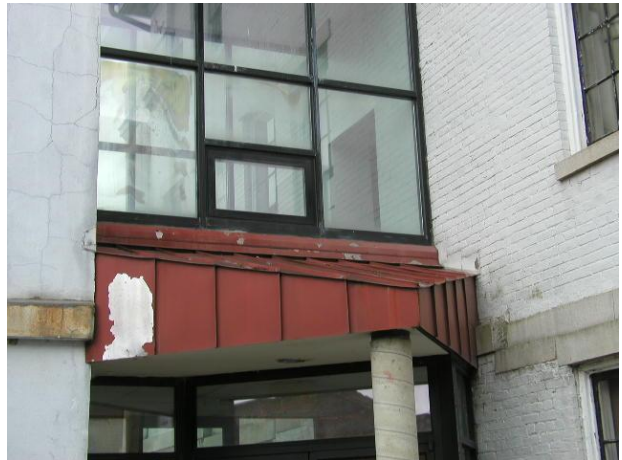
Photo No. 30
Observation – small roof area at rear entrance. Deteriorated finishes noted on the metal components.

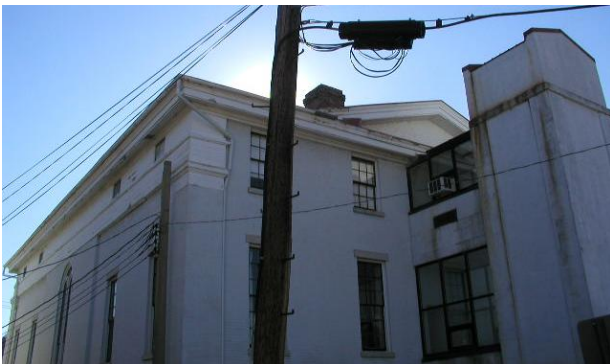
Photo No. 31
Observation – exterior mounted, half round gutter system. Downspout locations - front and rear corners.

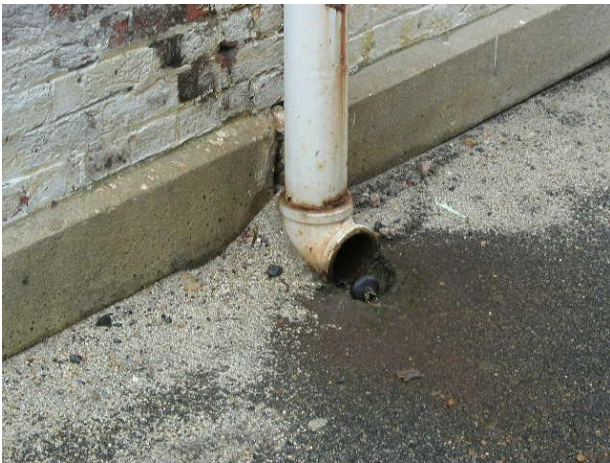
Photo No. 35
Observation – rear corner, west side - downspout routed to cast drain pipe and discharge at grade.

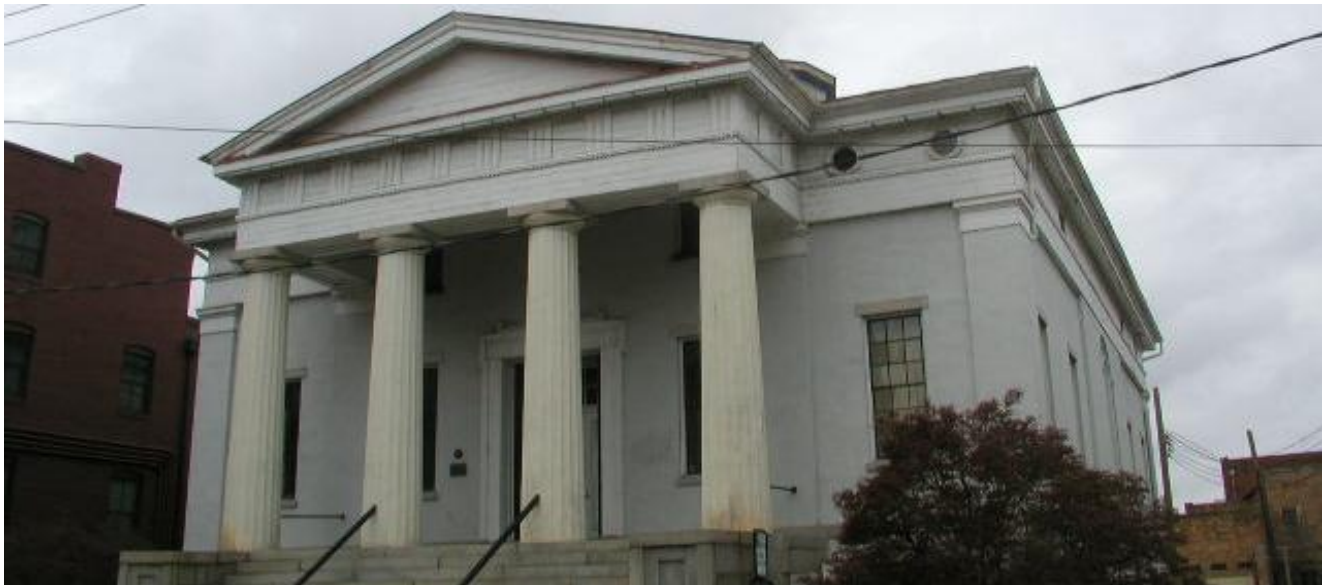
The existing roofing materials for the referenced roof areas at the Seige Museum are near the end of their life cycles and are in need of replacement. The areas may have a few years of service, however continued repair work can be expected. The existing roofing and related components have had repairs at specific areas in an effort to maintain the weatherproof integrity of the facility. The roof areas should be scheduled for replacement as soon as possible and as the facility programs develops. This is a grand structure and good design and specification is necessary along with a quality installation.
